**PUBLISHED TO RECORD  
THE UPS AND DOWNS  
OF THE  
KANSAS SOARING ASSOCIATION**

**October 2018**

<b>Aircraft Type and Registration:</b>	HPH Glasflugel 304 eS, G-GSGS	
<b>No &amp; Type of Engines:</b>	1 LZ Design D.O.O FES-HPH-M100 brushless electric motor	
<b>Year of Manufacture:</b>	2016 (Serial no: 059-MS)	
<b>Date &amp; Time (UTC):</b>	10 August 2017 at 1121 hrs	
<b>Location:</b>	Parham Airfield, West Sussex	
<b>Type of Flight:</b>	Private	
<b>Persons on Board:</b>	Crew - 1	Passengers - None
<b>Injuries:</b>	Crew - None	Passengers - N/A
<b>Nature of Damage:</b>	Fire damage to FES <sup>1</sup> batteries and FES battery compartment	
<b>Commander's Licence:</b>	British Gliding Association Gliding Certificate	
<b>Commander's Age:</b>	55 years	
<b>Commander's Flying Experience:</b>	314 hours (of which 25 were on type) Last 90 days - 9 hours Last 28 days - 7 hours	
<b>Information Source:</b>	AAIB Field Investigation

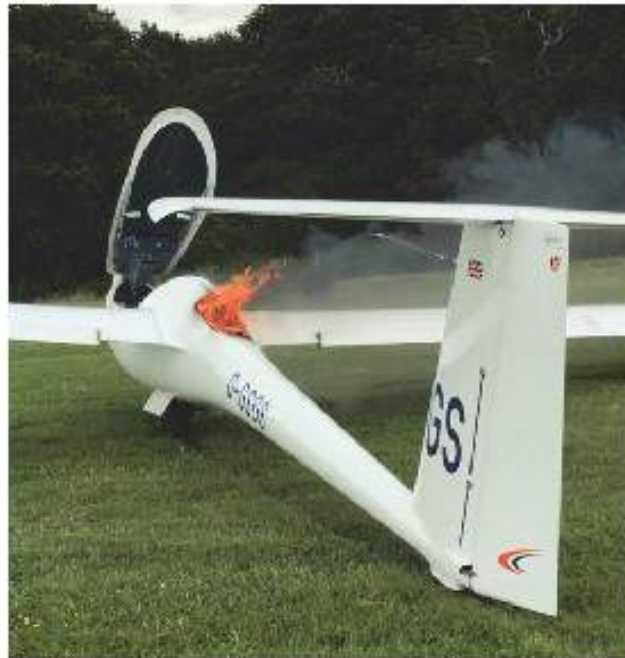
**Figure 1**

Fire in the FES battery compartment following the landing roll

The FES battery compartment cover was found close to the glider's touchdown point. The cover's rear carbon fibre catch was fractured, consistent with an upward load acting on the inside of the cover. The cover did not exhibit any overheating damage.

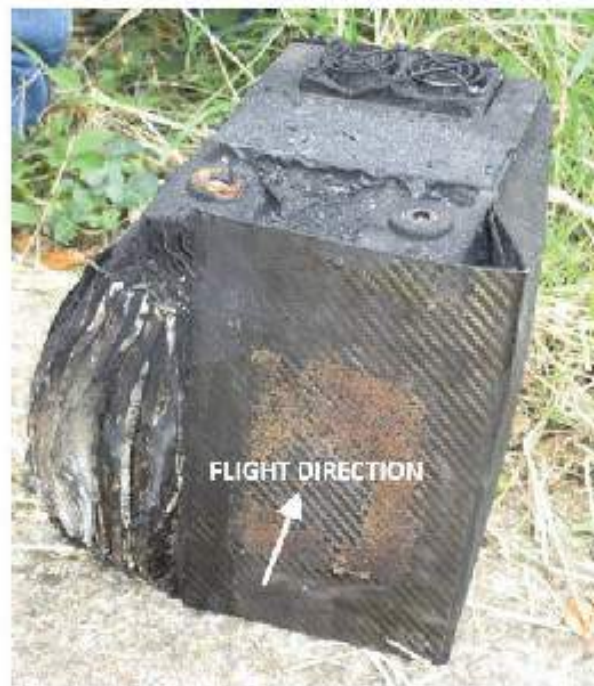
**Figure 5**  
Fire damage to the forward FES battery

The origin of the fire was the forward FES battery; its battery box was ruptured along the rear left corner and the battery assembly was heavily fire damaged (Figure 5). The rear battery box suffered from external fire damage although the internal components were only slightly damaged and the cells remained charged.

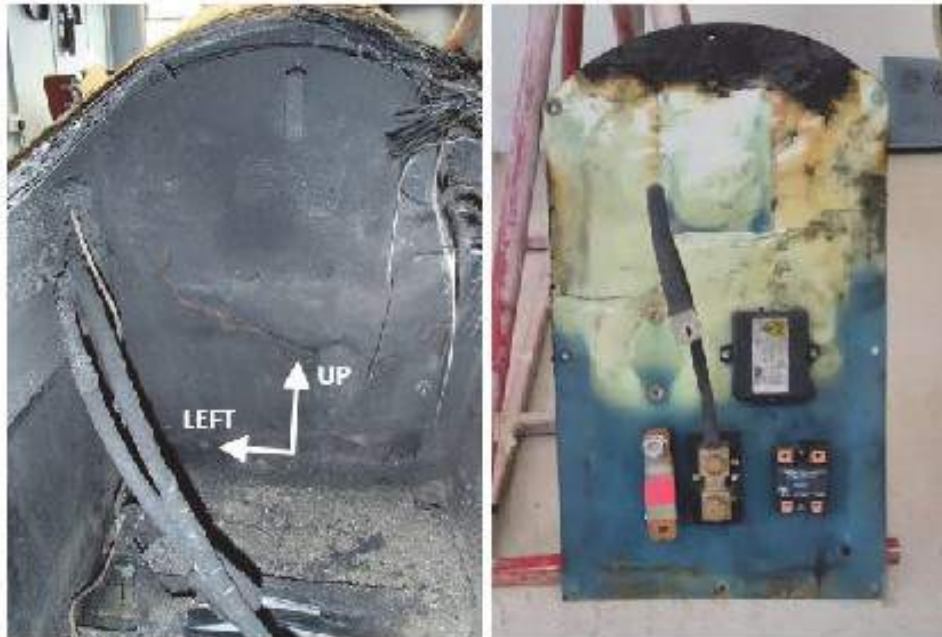
**Figure 6**

The FES battery compartment was heavily fire damaged with burning of the composite material's resin on the internal faces of the battery compartment and around the external cut-out in the upper fuselage skin. The top edge of the removable access panel that forms the front panel of the battery compartment (Figure 6) was also burned on its forward face and the FES electrical components in the equipment bay between the cockpit and the battery compartment were covered in soot deposits, demonstrating that the battery compartment had not contained all of the smoke and fumes released by the FES battery fire.

Fire damage to the FES battery compartment front access panel (left image, looking forwards), and to the forward face of the front access panel (right image, looking aft)

The HPH 304 eS sailplane manufacturer has replaced the composite battery compartment forward bulkhead with a stainless steel bulkhead to improve the fire-resistance of the bulkhead in the event of a battery compartment fire. The internal surfaces of the battery compartment are now painted in an intumescent fireproof paint finish.

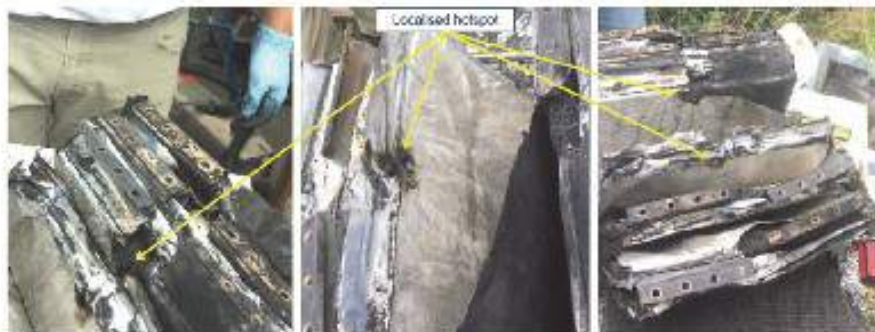
**Figure 7**

A localised hot-spot was observed between cells 5 and 6 on the upper edge of the cells in between the electrode tabs (Figures 7 and 8). The hot-spot was observed on the cell pouches and a number of the internal sheet electrodes were also exposed. The hot-spot did not appear to penetrate the whole cell pack thickness.

Localised hot-spot between cells 5 and 6 apparent during initial disassembly of the battery (courtesy British Gliding Association)

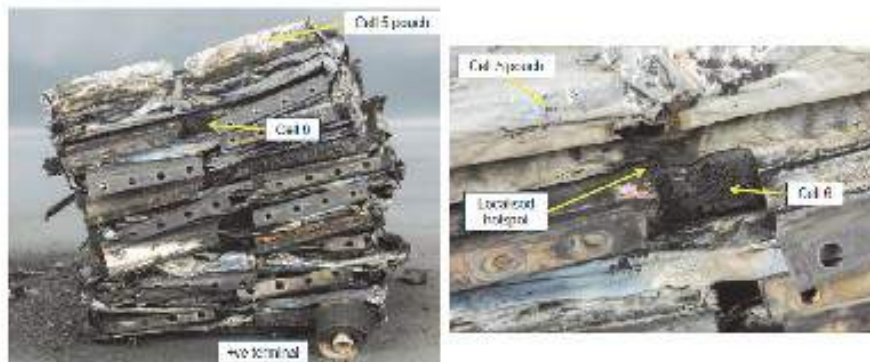
**Figure 8**

Localised hot-spot between cells 5 and 6 (courtesy QinetiQ)

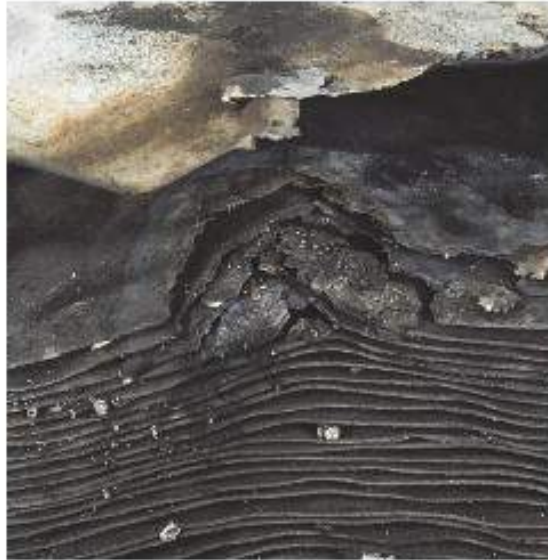
**Figure 9**

Examination of the hot-spot at cell 6 revealed localised melting of both the aluminium cathode and copper anode electrode sheets (Figure 9) indicating that the temperature at the hot-spot had exceeded 1,085°C, the melting point of copper. The presence of solidified molten copper was further confirmed by examination of the hot-spot location using a scanning electron microscope, and energy dispersive X-ray analysis of the molten copper deposits.

Localised hot-spot at cell 6, with solidified molten copper present  
(courtesy QinetiQ)

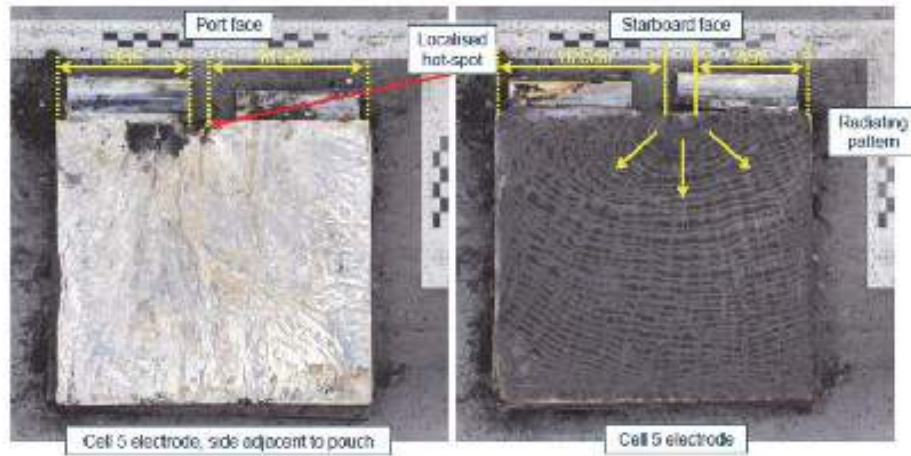
**Figure 10**

When cell 5 was disassembled, a radiating pattern of combustion-deposit 'beachmarks' was apparent, originating at the hot-spot (Figure 10). This indicated that ignition of the cell's gel polymer electrolyte had begun at the hot-spot location before burning downwards through the cell. Detailed examination of the hot-spot sites did not reveal the presence of any foreign objects at these locations. There was no evidence of 'welding' of the individual cell electrodes; the cell packs appeared to be fused together with combustion products, most likely the gel electrolyte residues.

Combustion front 'beachmarks' evident on cell 5 electrodes  
(courtesy QinetiQ)

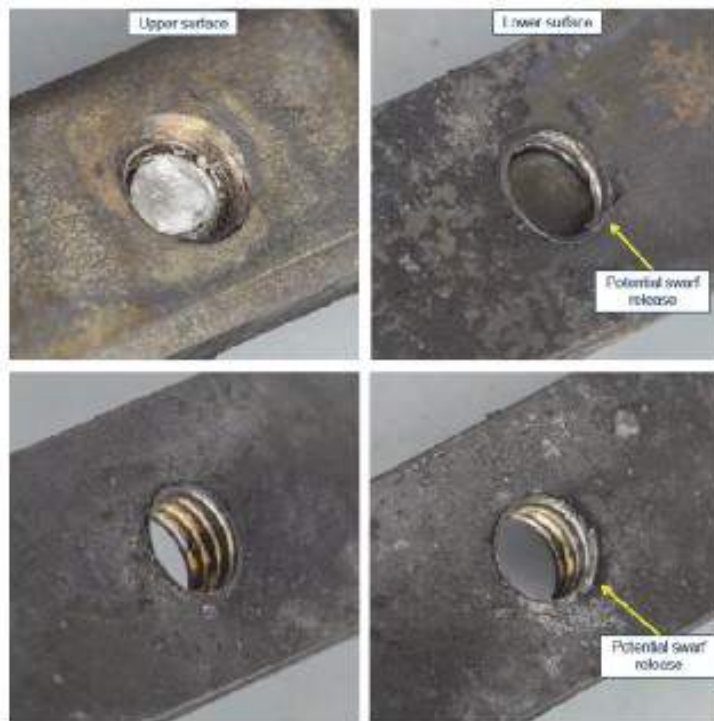
**Figure 11**

Examination of the lower stainless steel cell connector plates showed a burr present on a number of the drilled and threaded holes, on the lower surface of the plates (Figure 11). The visual examination also showed the potential formation of swarf from these burrs.

Thread-cutting swarf present on the lower surface of the connector bars  
(courtesy QinetiQ)

The new FES battery features additional nomex-mylar insulation between the cells and an increased quantity of silicone encapsulation of the battery cells to prevent foreign objects from falling between the cells. The edges of the battery cells pouches are covered in an electrically-insulating tape to prevent electrical discharge of the cell should the cell pouch seal fail. The stainless steel battery cell connector plates have been replaced with anodized aluminium plates which have been demonstrated not to eject machining swarf from screw threads when the connector screws are inserted during assembly.

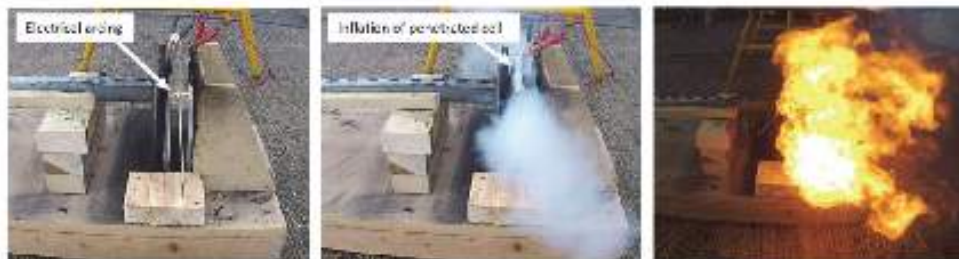
**Figure 12**

The electrical arcing was immediately followed by rapid inflation of the cell pouch and the ejection of light grey smoke, followed shortly by flames. The fire continued for approximately two minutes until the gel electrolyte polymer, which was the main fuel source involved in the fire, was fully consumed.

Electrical arcing following cell penetration

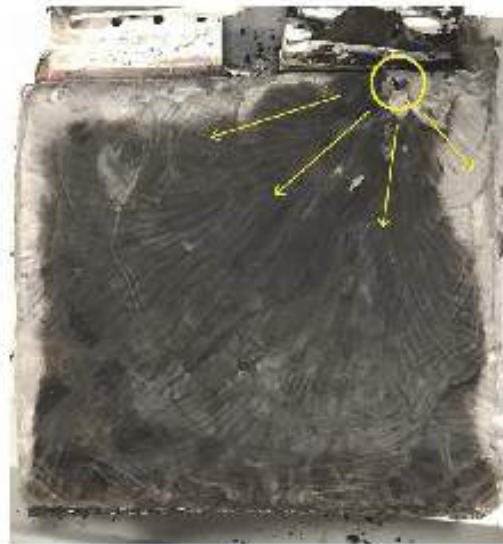
**Figure 13**

Examination of the steel nail after the tests showed that it had melted in the initial electrical arcing event, indicating that the temperature generated during the arcing was in excess of 1,400°C. The cell electrodes at the penetration site had a hole of larger size than the nail diameter, the edges of which were formed from solidified molten electrode material, consistent with the melting of the electrodes during the arcing event. The remaining copper and aluminium electrodes were relatively intact, demonstrating that the temperature reached during the combustion of the cell's gel electrolyte was relatively cool compared to the electrical arcing temperature. A pattern of combustion 'beachmarks' originating at the nail penetration site was observed (Figure 13) these were similar to those observed in the fire-damaged battery from G-GSGS.

Combustion benchmarks from AAIB cell penetration tests

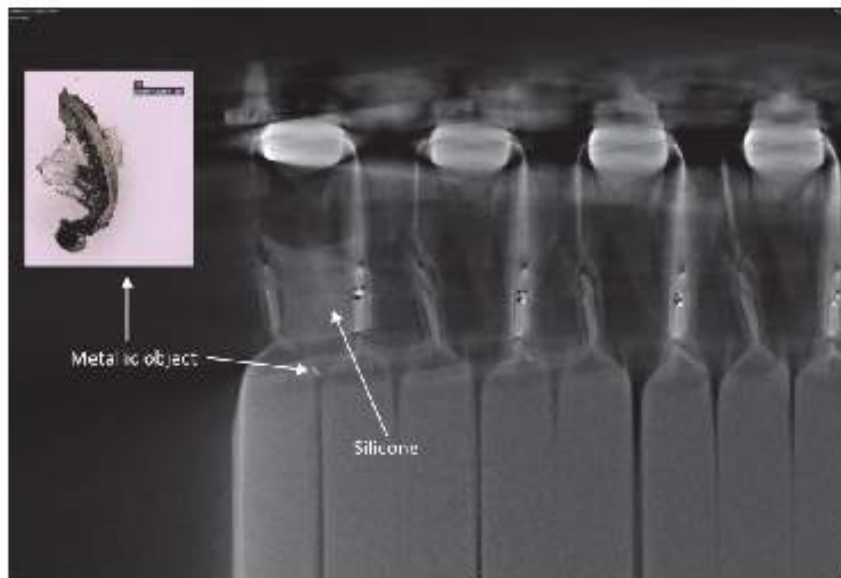
**Figure 14**

The CT scan of battery pack 080-B, the rear battery pack from G-GSGS, contained one metallic object lying between two cells at the top of the pack (Figure 14). This object was beneath the silicone layer indicating that the foreign object has been present when the battery pack was assembled.

The battery pack was disassembled and the metallic object was recovered. The object was a piece of metal swarf, 2 mm in length, with a distinctive curved shape consistent with the swarf generated during the thread-cutting process of the connector plates.

Metallic swarf debris within battery pack 080-B (courtesy QinetiQ)

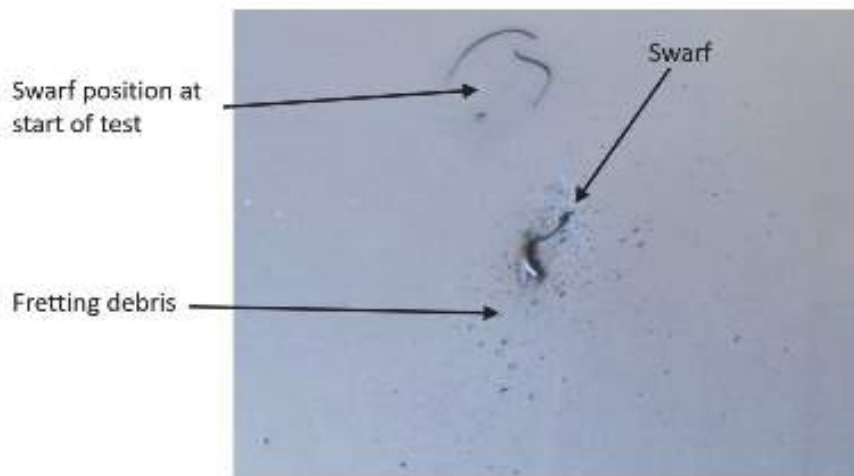
Figure 16

A second test was conducted with 3.0 mm lengths of steel swarf inserted between the cells (Figure 16). The cells were vibrated in the horizontal axis for 30 minutes at a resonant frequency of 20 Hz, during which there were no signs of fire, smoke or unusual odours. Following this test, the cell fixture was disassembled and it was noted that there had been migration of the swarf within the cell fixture and some fretting of the cell pouch material due to contact with the swarf, but the fretting depth had not exceeded the pouch thickness and no electrolyte had been released.

Cell pouch fretting during vibration testing with metal swarf present
